Electrical Distribution System

The electrical distribution system in Puerto Rico, which is installed on wood or concrete poles, was severely damaged by Hurricane Georges. The loss of electrical service to water treatment plants resulted in widespread disruption of the delivery of water, which directly affected people's personal lives. Loss of electrical service also resulted in major economic disruption and significantly increased disaster response needs.

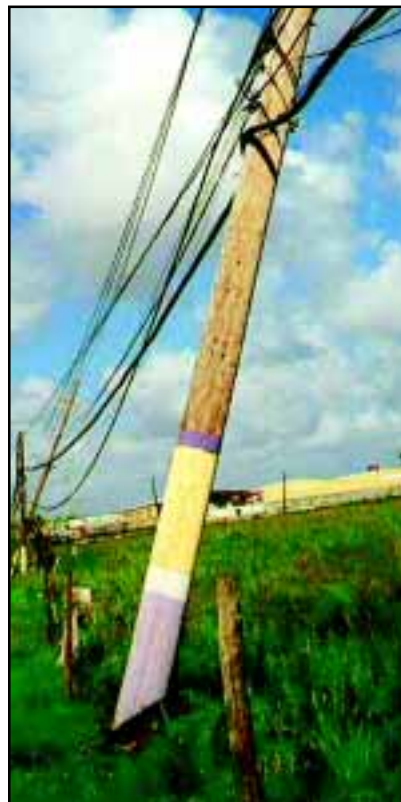
FIGURE 7-2 Leaning wood pole due to inadequate embedment.

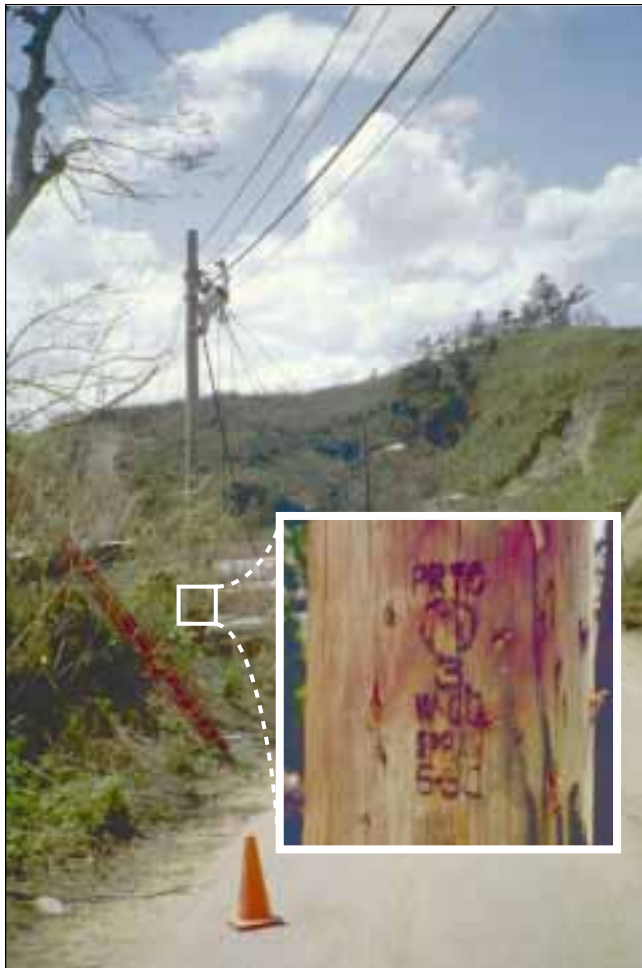
FIGURE 7-4 New wood pole replaced after the hurricane; utility lines are still being attached to the pole. Inset shows wood pole grade marking. This #3 pole was typical of those used throughout the island.
